Kenecott Greens Creek Site Visit November 23, 2004

Kenwyn George, P.E., Environmental Engineer, ADEC-AWQ

This site visit was conducted in conjunction with Laurie Thorpe of the USFS to look at the Tailings facility expansion area, Sulfate Reduction Monitoring Program progress, Site 960 materials removal progress and the present status of Waste Rock Site 23.

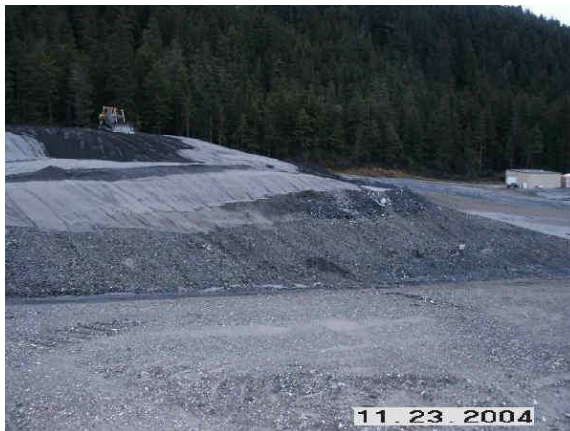
Tails were being placed to the east between the original tailings pile and the new road located on top of the slurry wall on the hillside. At the previous quarry area to the east / southeast of the site, base rock has been placed, a geotextile cover installed and covered in sand, and an initial pass of compacted tails placed. The power line to the waste water treatment plant has been relocated from adjacent to the old tails pile to a location further north on the same latitude as the treatment plant. This will enable expansion of the pile to the north.

East/southeast tailings area

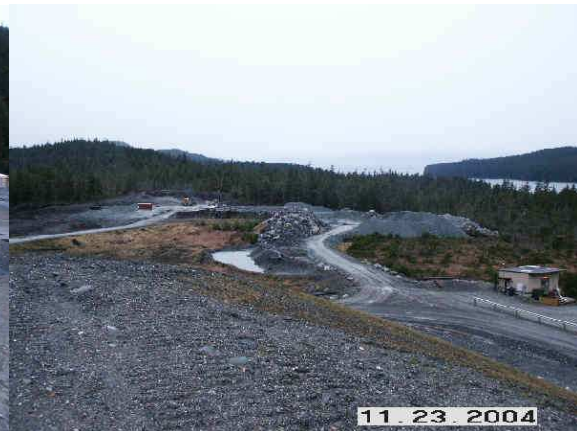
Tailings expansion area

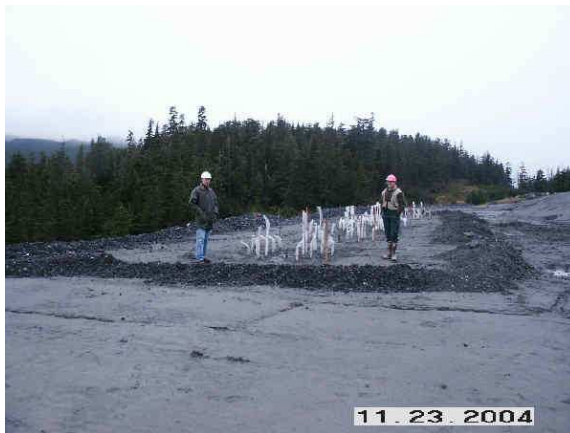
Small "cells" comprised of admixtures within tubes will also be studied in a laboratory during the winter. At the tailings facility, cells 3m x 3m x 4m deep, lined on the sides but not the top or bottom (except for cell No 1 which is an unlined control site) have been installed at the western edge of the top of the existing pile. These cells were set on a small bench in the face of the tailings pile such that they can remain accessible as future tails are placed and the main pile rises higher beside and behind the cells. In each of the 3m x 3m cell sections there are 2 sets of 8 suction lysimeters (16 total), at various depths on opposite sides of each cell. These lysimeters will collect samples from 1.5m deep to 4m deep. In 2005 gas sampling tubes will be installed in each of these cells.

SRMP site at west edge of tails pile

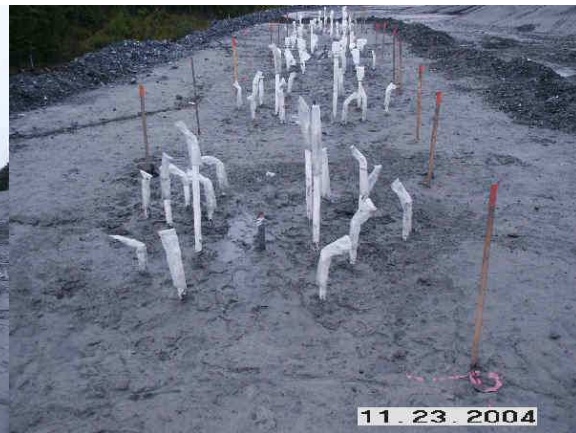
SRMP – lysimeters and sample ports

Tails were excavated from 6 of the 7 cells and carbon sources (local peat, biosolids, & spent brewery grain mash) intermixed with them adjacent to the excavations. The material was then replaced in the cells and compacted to replicate as near as possible the density of the existing tails. Lysimeter sampling points were then hand augered using a power auger (a hard job with all the friction and weight, especially for the deeper holes). Klohn-Krippen had conducted pile stability analyses with the various tails/carbon source mixtures and stated that there should be no greater than 5% by volume of any additive or combination of additives.

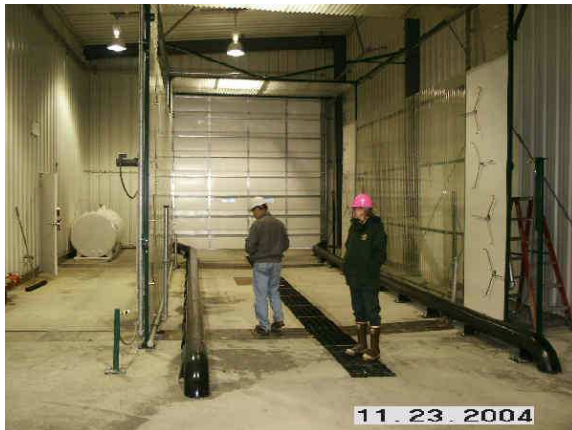
The old truck wash facility is located in the tailings expansion area. This old truck wash station will be removed from the site. Replacing this is a new truck wash facility being constructed at the periphery of the expansion area to the southeast. It is a more sophisticated truck wash that washes the wheels and underside with two sets of upward-pointing jets and side-mounted spray sets.

New truck wash

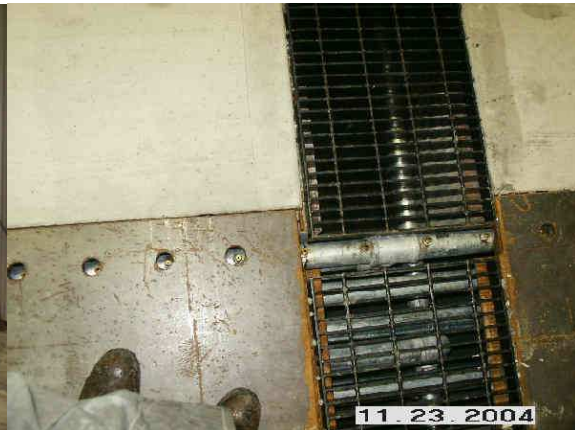
Vertical jets to wash tires & underside of trucks

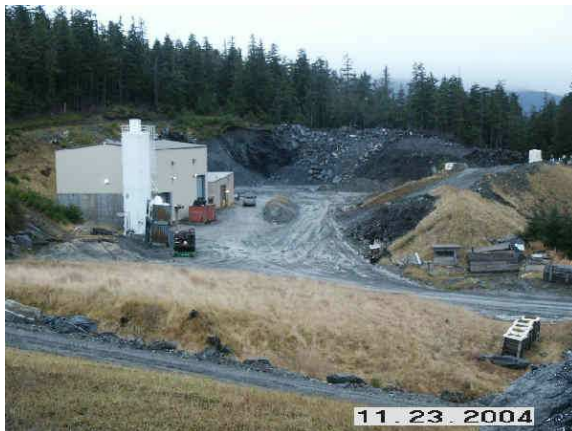
Rock excavation has ceased in this area. There are still rock walls, however the rock will not be quarried for use in locations around the site because it contains too much pyrite; it is better to leave it undisturbed and in place. Eventually tails will fill the pit and will be placed against these rock walls.

Waste Water Treatment Plant and Pit 5

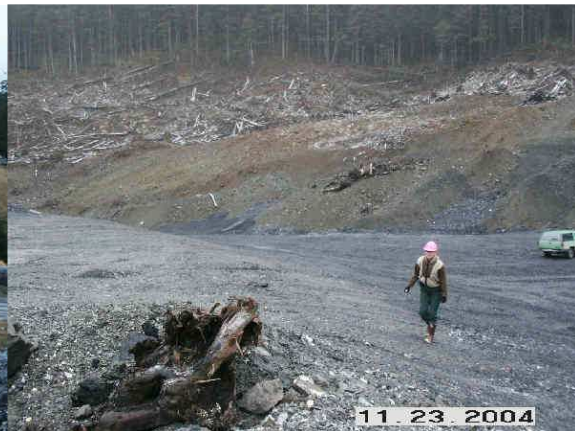
Top rear at Site 23

The “valley” to the rear of the upper area of the site has been filled considerably. Class 1 material continues to be placed at the outer periphery of the pile and class 2 and 3 rock is placed in piles, and then blended to form the main part of the pile.

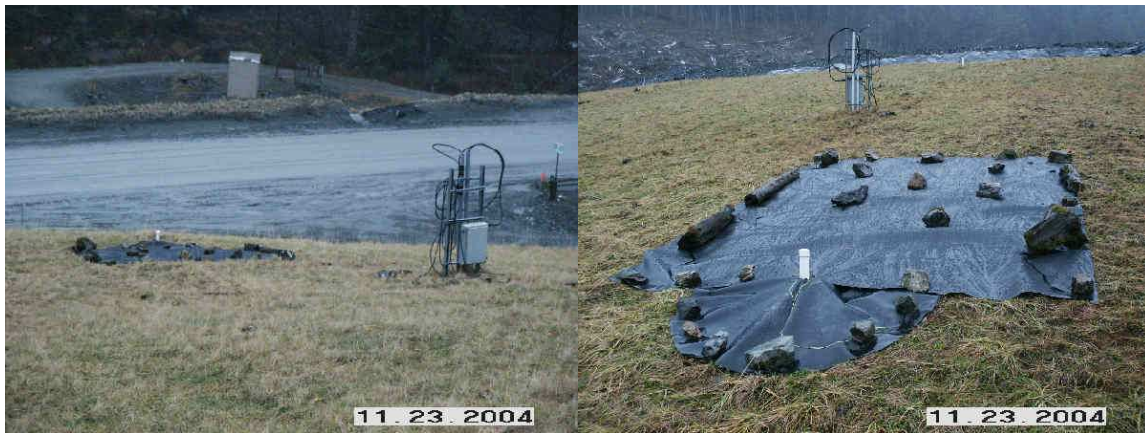
The cap now has three years of healthy growth upon it and small spruce seedlings were visible on the cap. The infiltration rate is being monitored into a constructed lysimeter. Infiltration rates are higher than anticipated (now being between 15% and 20%); the reasons for this are unknown. The lysimeter chamber was sealed to try to keep up-gradient water from flowing into it. This did not significantly affect the measured infiltration rate. Presently a 10' x 20' polyethylene sheet has been placed on the cap surface to see whether local isolation of rainfall affects the infiltration rate. If little difference is noted, the polyethylene sheet will be laid further upslope. For possible consideration is the use of tracers such as sodium bromide to see what the source of water is, e.g. whether it is water flowing down slope under the cover. Infiltration response rates have been rapid after rainfall events at about 2 days, far faster than would be expected from percolation through the cover at around 2 weeks, so it is quite likely there is infiltration from water running down-slope within or beneath the cover.

Site 23 lysimeter

Polyethylene “isolation” cover (note grass growth).

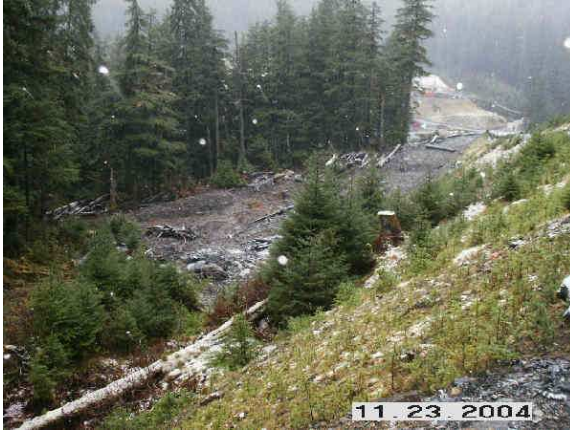
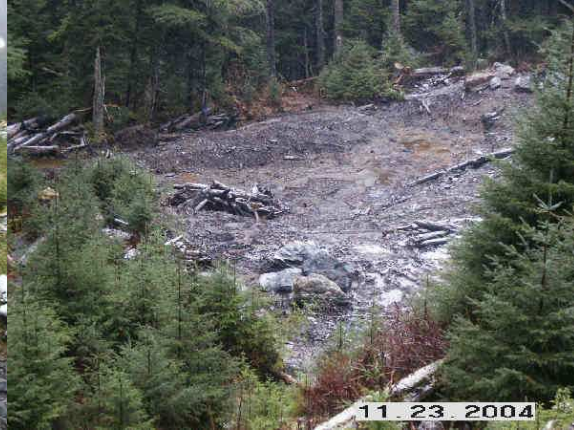
Site 960

Virtually all material has been removed from the site, down to natural clays. There is still acidic run-on from beneath the road above, but that is most likely from natural sources. There is also a stream that runs to the south side of the site, a portion of which now flows onto the excavated area at the lower side. Some original fill material remains in the upper access ramp area; this will be moved after the site has been found stable, and final grading completed with clean-up.
